**CHARACTERIZATION OF AQUATIC HABITATS OF
SOUTHERN CAYUGA LAKE TRIBUTARIES AND SHORELINE,
ITHACA, NEW YORK**

City of Ithaca

EcoLogic, LLC
Atwell Mill Annex, Suite S-2
132 ½ Albany Street
Cazenovia, NY 13035
(315) 655-8305

August 11, 2008

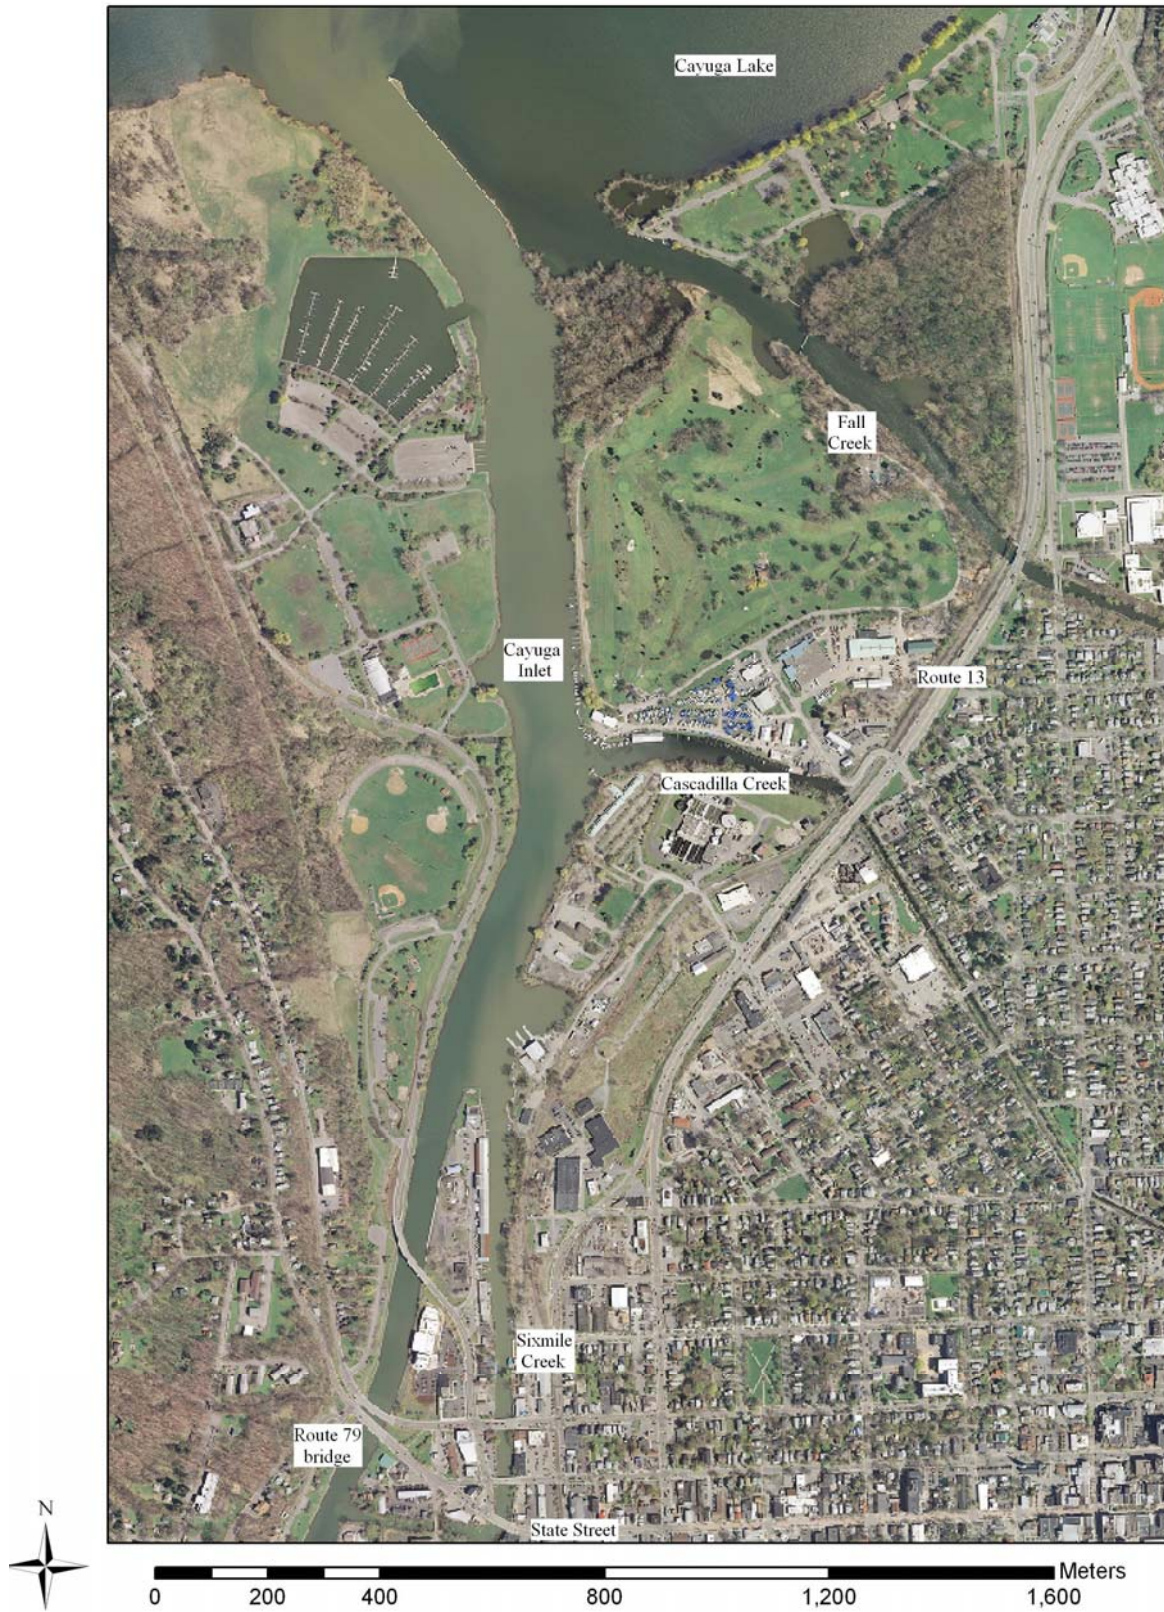
Figure 1. Study area for habitat characterization of southern Cayuga Lake tributaries and shoreline conducted July 17-18, 2008.

The aquatic habitat characterization was limited to the southern Cayuga Lake tributaries (Cayuga Inlet and Sixmile, Cascadilla, and Fall creeks) and shoreline that could potentially be affected by the proposed dredging project (Figure 1). This included the following areas.

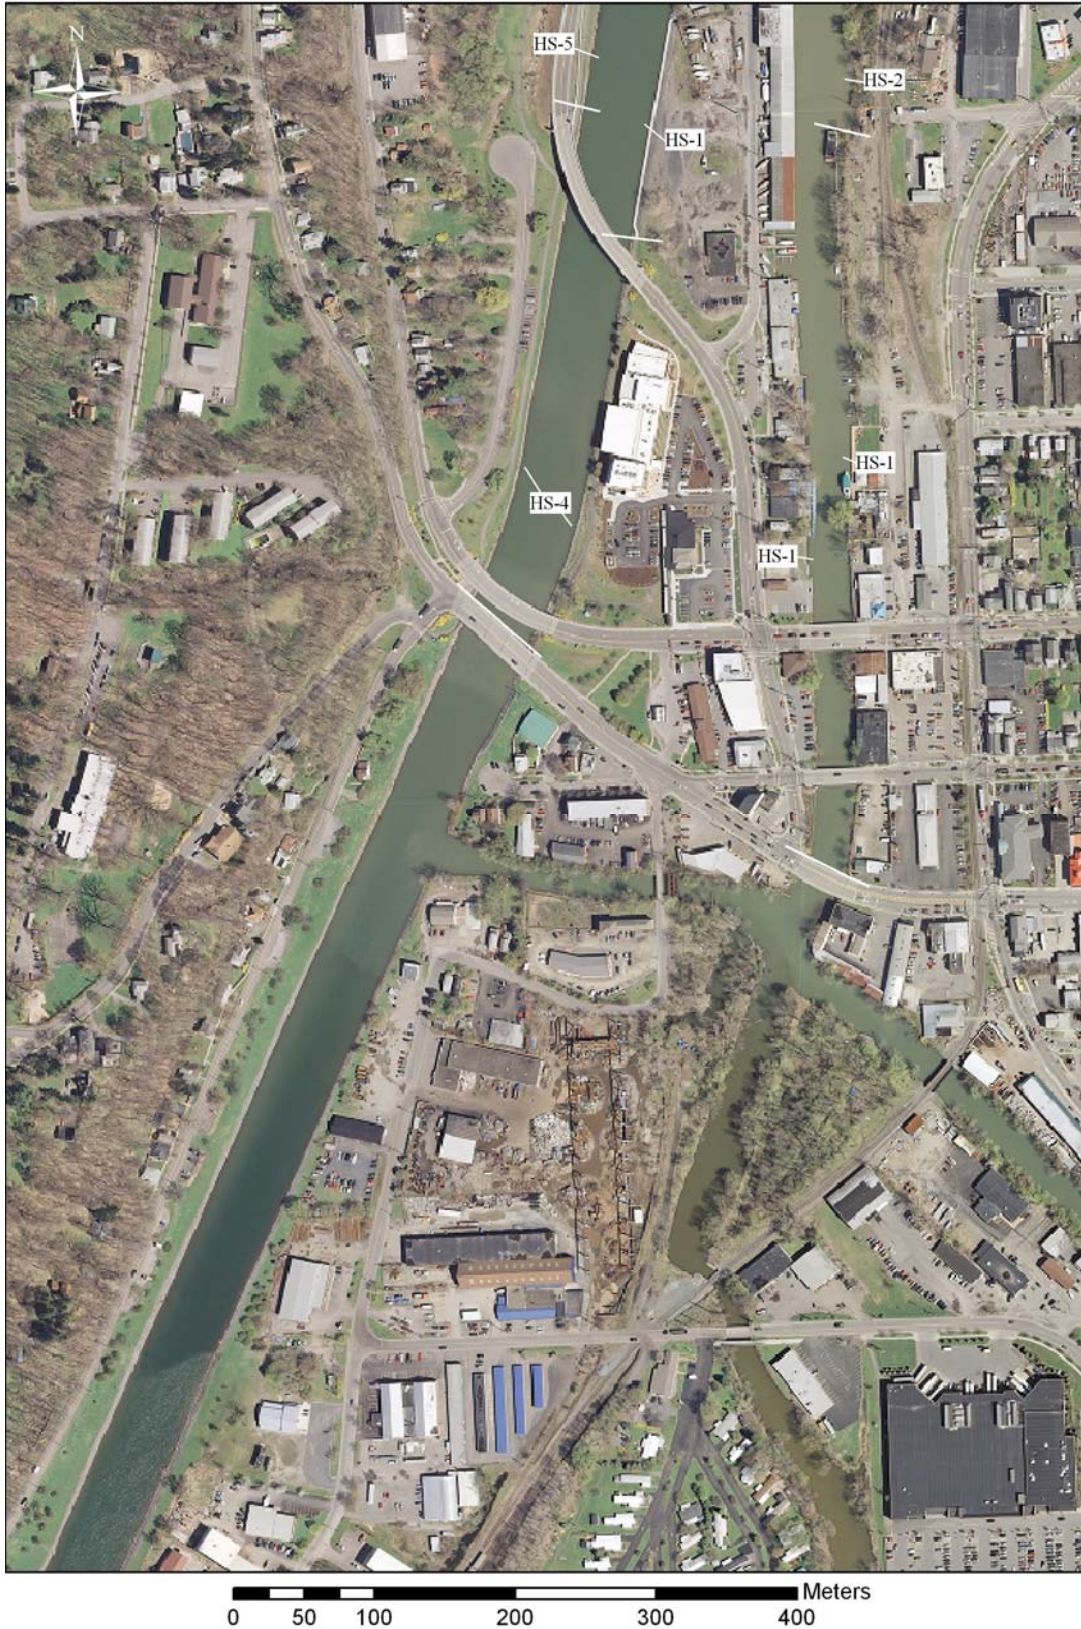
Figure 2A. Habitat units identified during the habitat characterization of the southern tributaries and shoreline of Cayuga Lake, July 17-18, 2008.

This habitat unit is abundant in portions of Sixmile Creek, Cascadilla Creek, and Cayuga Inlet (Figure 2A-C). It is characterized by significantly human-modified shoreline consisting of wooden, concrete, rock, or metal bulkheads, docks, retaining walls, riprap, or other structures (Table 1, Photos 1 and 2). These structures provide the bulk of the available in-water cover, which is generally abundant. Aquatic vegetation is generally lacking. Depth in near-shore areas often exceeded 5 ft. Littoral fish species [e.g., sunfish (*Lepomis* spp.), bass (*Micropterus* spp.), and minnows (Cyprinidae)] may make use of this habitat due to the cover provided by the various structures. Wildlife use of this habitat is limited due to a general lack of forage and terrestrial cover, though some passerine birds and ducks (mallard, *Anas platyrhynchos*) were observed in this habitat. Recreational use of this habitat in the form of boating is heavy.

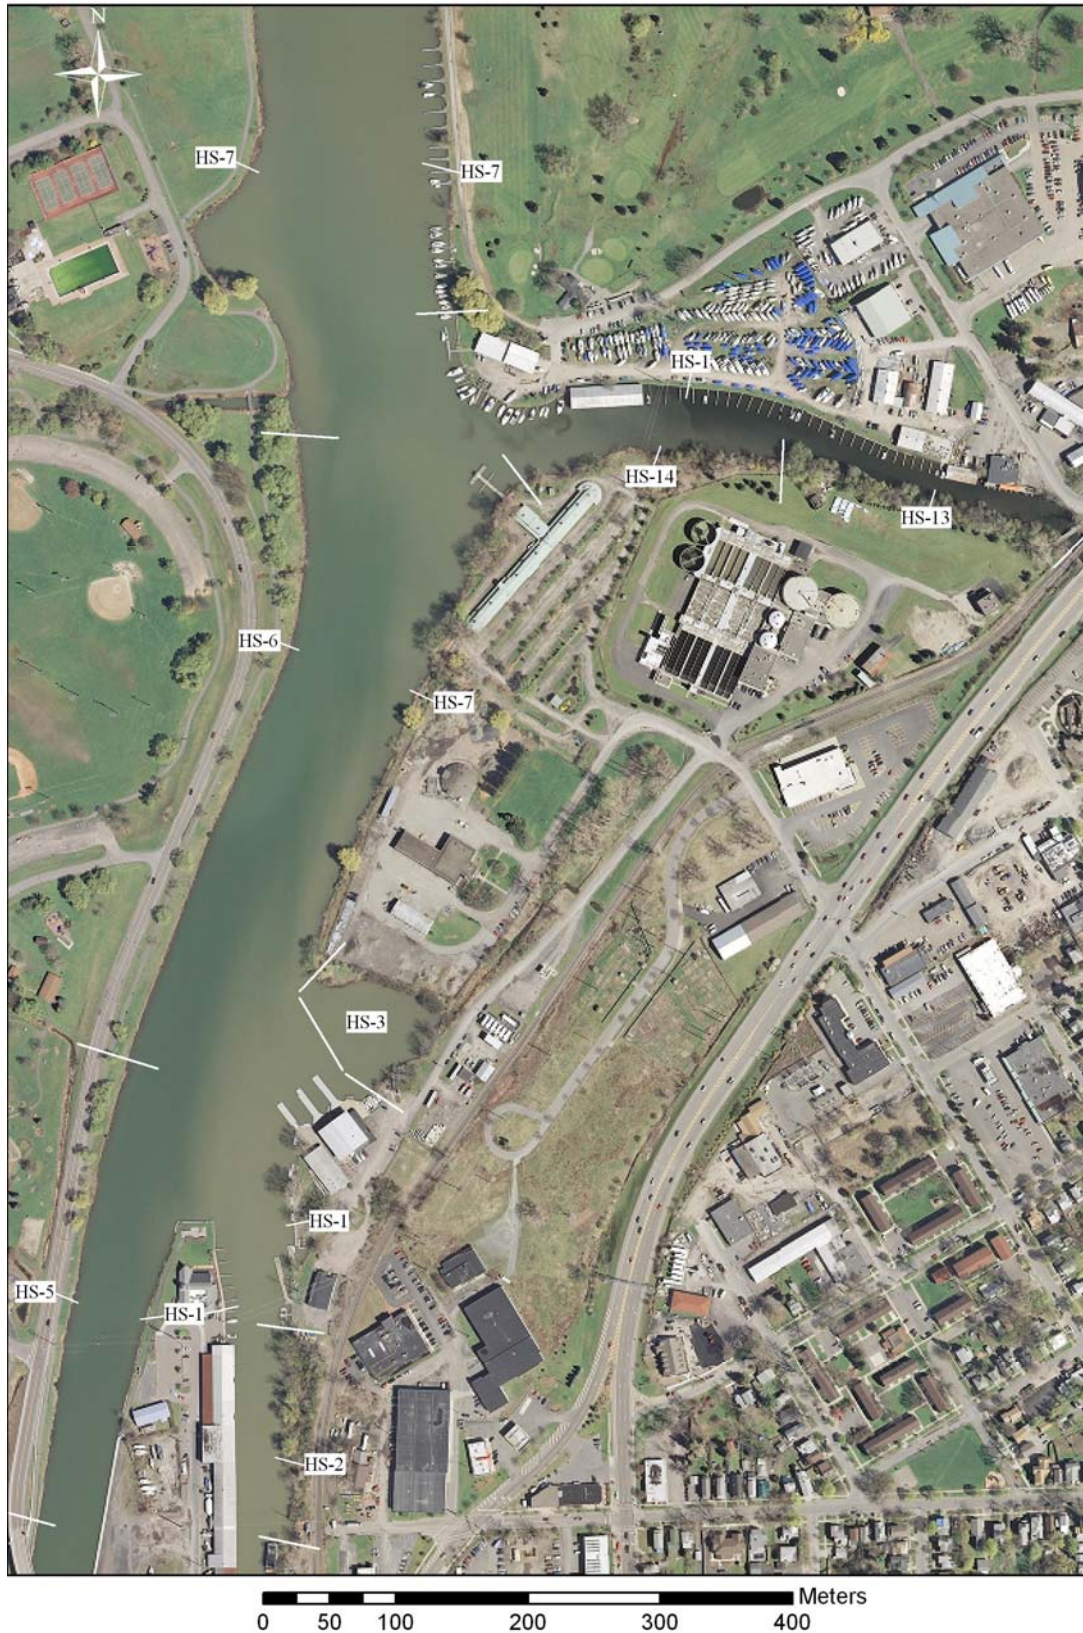
Figure 2B. Habitat units identified during the habitat characterization of the southern tributaries and shoreline of Cayuga Lake, July 17-18, 2008.

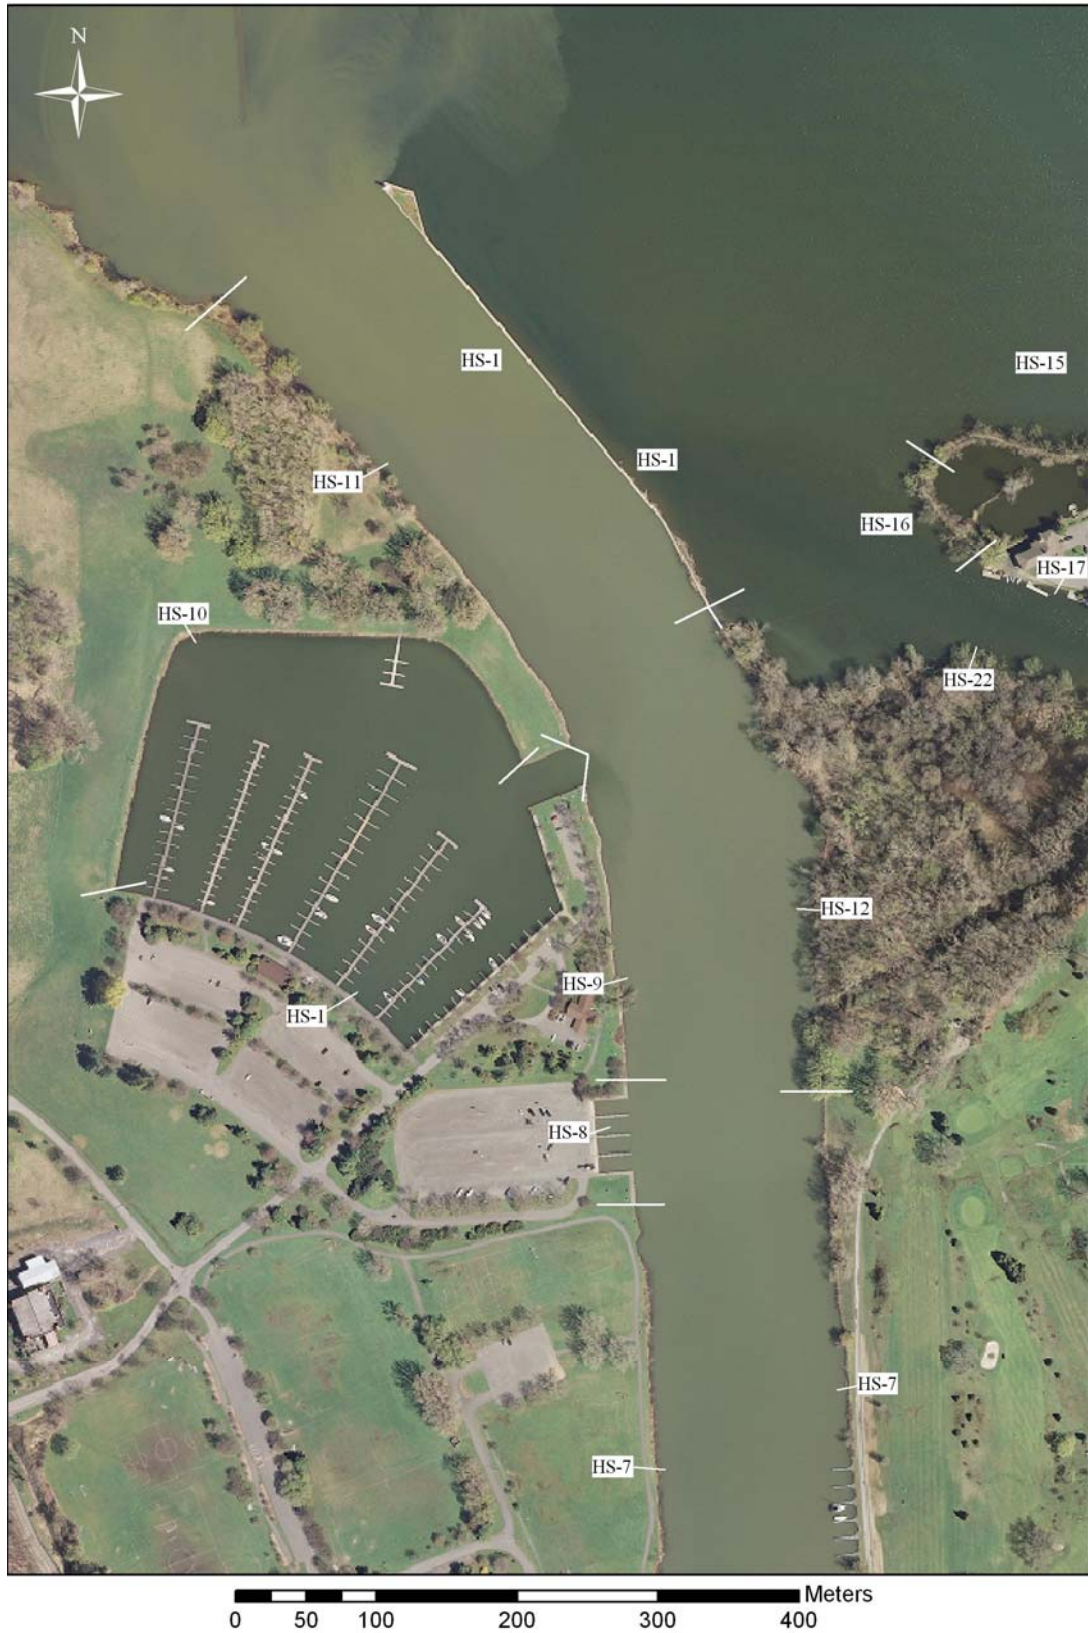
Figure 2C. Habitat units identified during the habitat characterization of the southern tributaries and shoreline of Cayuga Lake, July 17-18, 2008.

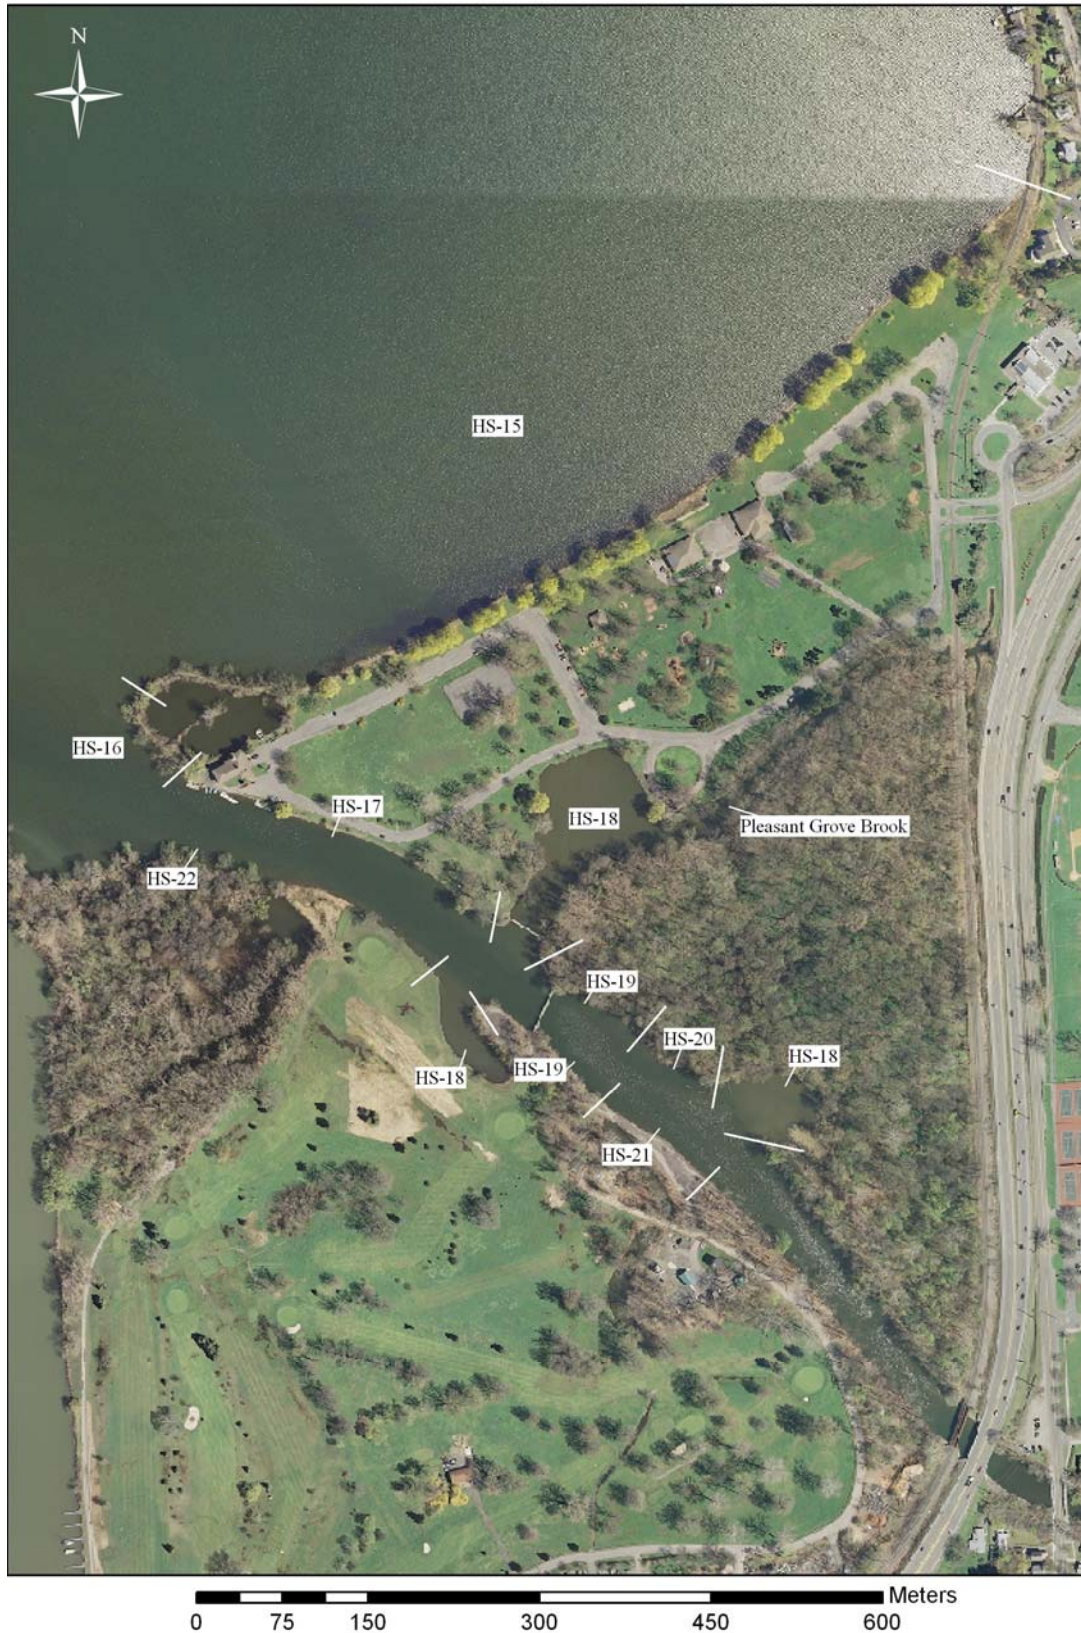
Figure 2D. Habitat units identified during the habitat characterization of the southern tributaries and shoreline of Cayuga Lake, July 17-18, 2008.

Habitat unit 17 is located along the east side of Fall Creek at the west end of Stewart Park (Figure 2D). This habitat is characterized by a steeply sloping bottom with gravel, cobble, and boulder being the primary substrates in the near-shore area (out to depths ≥ 4 ft) (Table 1, Photo 20). Docks at the north end of this unit comprise the predominant cover. No aquatic vegetation was observed. Water depth reaches 4 ft not far (within 20 ft) from shore and is up to about 7 ft near mid-channel.

Habitat unit 21 is located along the west shore of Fall Creek upstream of the foot bridge near Stewart Park (Figure 2D, Photo 25). The most notable feature of this habitat is the gravel/cobble substrate found both near shore and off shore (Table 1). There is no notable cover in this habitat, and depth ranges from 1-4 ft. No aquatic vegetation was observed.
